Structural Assessment

DENTON FIELD STADIUM – MILES CITY, MT

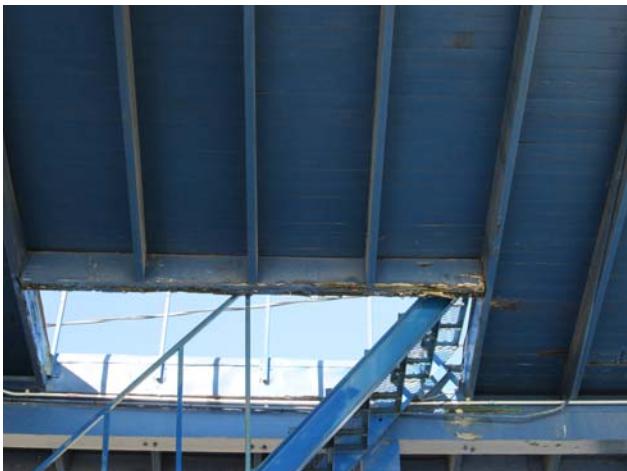
A limited gravity load analysis was performed on canopy roof members. Load calculations for the 2x8 joists and 8x8 timber beams indicated that these members (in good condition) would be satisfactory to carry the design roof loads. There were some areas that had suffered moisture deterioration as a result of roof leaks but it appears those areas could be repaired. The framed opening for the stair access through the roof to the press box had significant deterioration and rot (Photo 1) and would require to be reframed, as did at least one of the 8x8 timber beam ends (Photo 2).

Photo 1 – Stair Opening in Roof

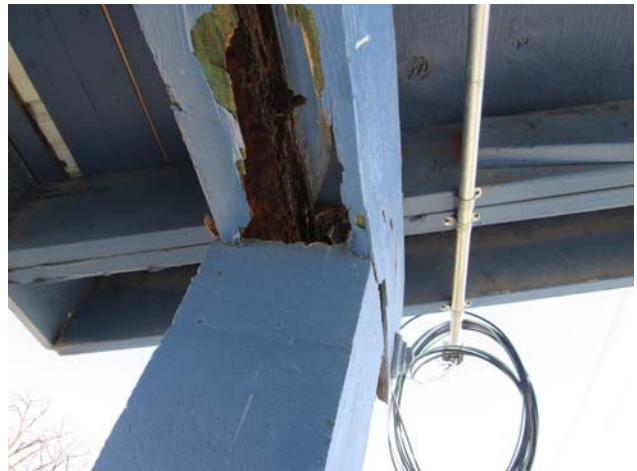
Photo 2 – 8x8 Timber Beam Deterioration

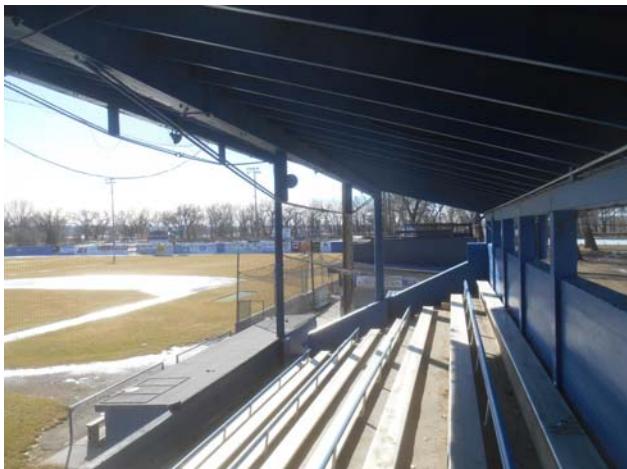
Load calculations for the tension rod beam assemblies (Photo 3) that support the roof joists, indicated a very limited load capacity. Calculations showed safe load capacity to be only the self-weight of canopy roof with very little snow load allowance. The calculations were based on the premise the beam assemblies were in good condition, deterioration in components would further reduce the carrying capacity. Although we had a limited view of the beam assemblies from below, it did appear that deterioration at the ends and exposed faces of the beam assemblies along the front side of the stadium has occurred (Photos 4 & 5).

Photo 3 – Stadium Tension-Rod Beam Assemblies

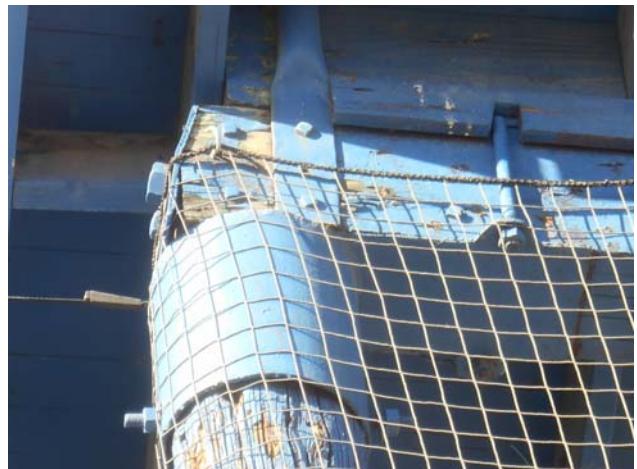
Photo 4 – End Condition of Beam Assembly

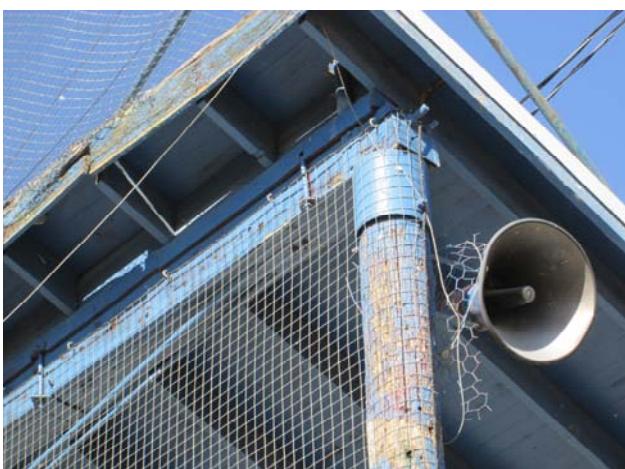
Photo 5 – Opposite End Condition of Beam Assembly

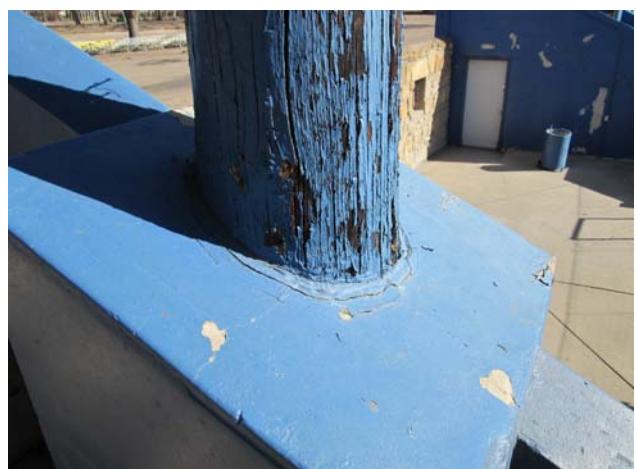
Eight wood poles support the canopy structure. Two of the poles were interior and appeared in satisfactory condition. The other six poles were around the canopy perimeter were subject

to more severe weathering and exhibited various levels of deterioration.

Photo 6 – Wood Pole Base
